**Training for Renovated Energy Efficient
Social housing**

Section 3: Case studies

3.6 Husby Terrasse, An example from Norway

Case: Husby Terrasse, “ from 250 to 120 “

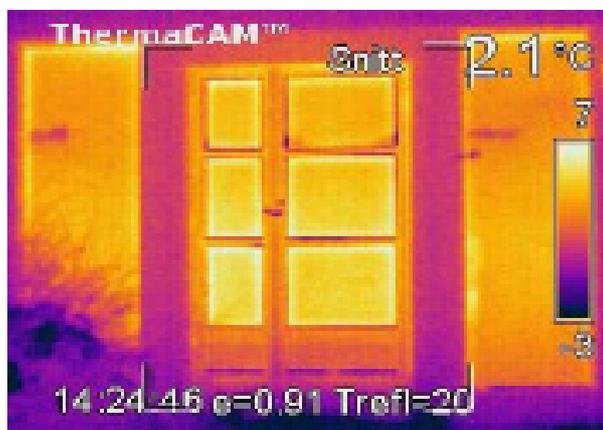
Slide 4

The inspection was supported by thermo photographing.

Picture taken from outside.

Average temperature [balconydoor] is 2.1 °C.
Light/Yellow colour indicate temp.up to + 7 °C.
Dark/blue colour indicate temp down to - 3 °C.

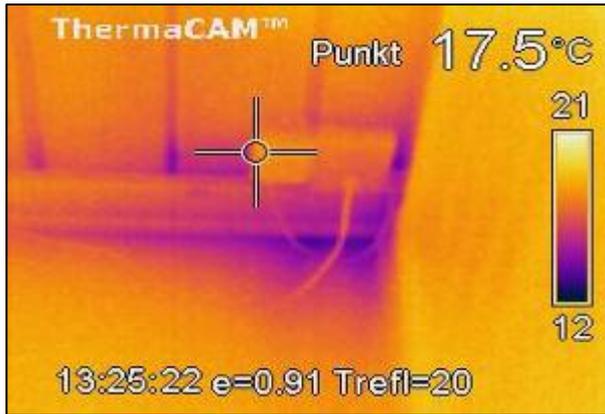
Slide 5

Thermal photo is a useful way to detect thermal bridges.

Picture is taken from inside

The picture is detecting thermal bridges in the joint between external walls and the floor (concrete slab)

The pedestals in the wall is detected as well

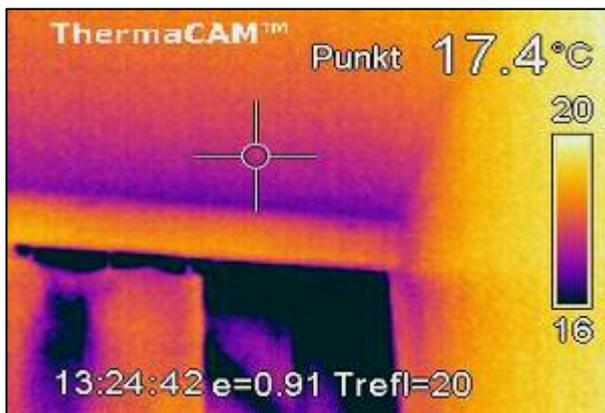
Slide 6

Picture is taken from inside

Thermal bridges in the joint between external walls and the ceiling/floor

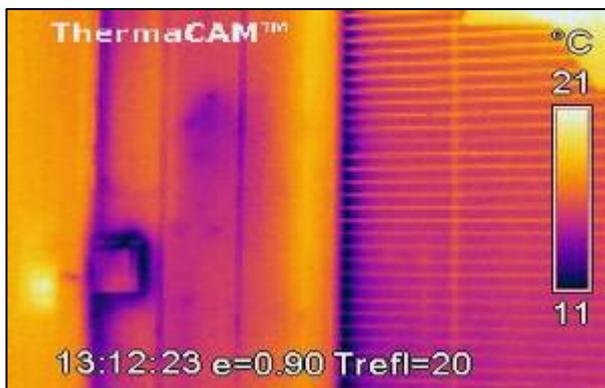
Slide 7

Picture is taken from inside

Thermal bridge/air leakage in electrical switches (left)

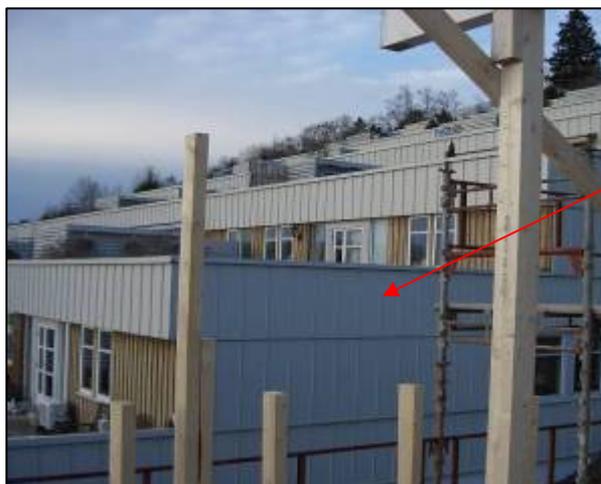
Slide 10

Picture is taken of outside east wall before adding insulation.

As a first step these steel panels are removed
