**Training for Renovated Energy Efficient
Social housing**

Section 3: Case studies

3.6 Husby Terrasse, An example from Norway

Case: Husby Terrasse, “ from 250 to 120 “

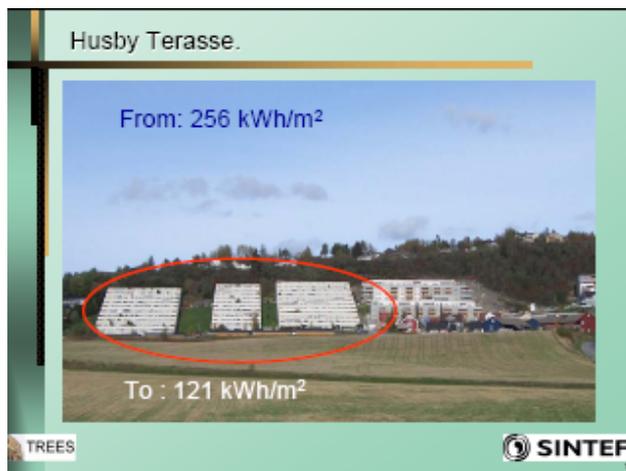
Slide 1

Husby Terrasse consist of 110 apartments, erected in the middle of 1970. Like other domestic buildings in Norway from that decennium, energy efficiency was not given too much attention. Combined with failure in window sealing system, and poor ventilation systems, the energy consumption was measured to approx. 255 kWh/m² year

In the beginning of year 2000 the owners decided to execute a major rehabilitation. Trough this upgrading the energy target was set to 120 kWh/m² year. Approximately half of the measured energy use.

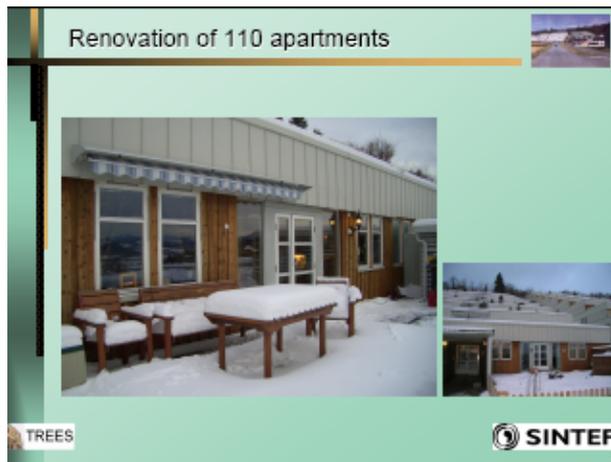
Slide 2

As the name alludes, the buildings are organized as terraces. The facades are faced to south and consist of approx. 50 % glassed area. (balcony door and rather big windows.)
